ORAL REHABILITATION WITH CAMLOG IMPLANTS

AFTER LOSS OF DENTITION DUE TO AN ACCIDENT

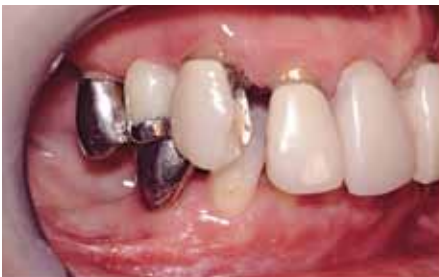
Fig. 1: Clinical situation: The occlusion had collapsed as a result of the traffic accident.

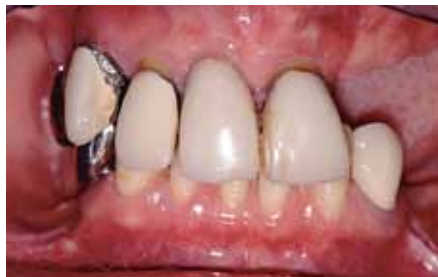
Fig. 2: Only the upper and lower anterior teeth were incorporated or involved in functional occlusion.

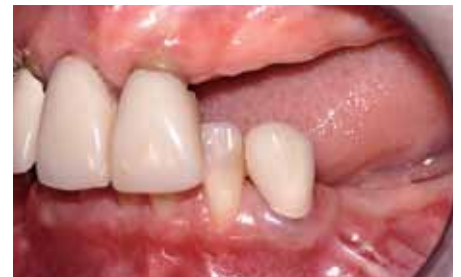
Fig. 3: The upper anterior teeth were mobile and hopeless. They were extracted.

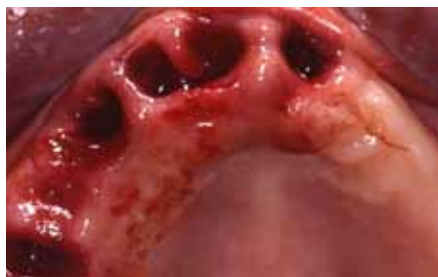
Fig. 5: The maxillary teeth were carefully extracted.

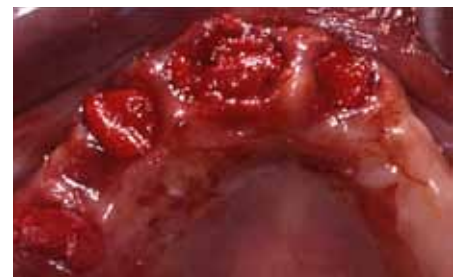
Fig. 6: After extraction, on the right side, ridge preservation technique was applied to preserve the soft- and hard-tissue contours: The alveolar sockets were filled with Bio-Oss® and covered with Bio-Gide® membranes. The extraction sockets on the left side were left untreated.

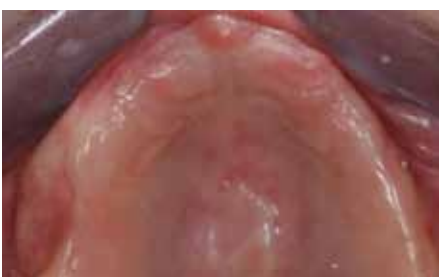
Fig. 7: Clinical situation after 6 months: nicely healed soft-tissue contour of the alveolar ridge. The right side seems to demonstrate a wider dimension of the alveolar crest.

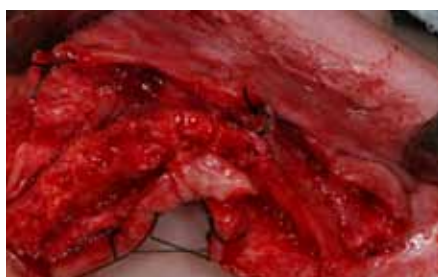
Fig. 8: Full-thickness flap preparation, demonstrating the dimension of the alveolar bone crest. Note the difference in bone width between the left side (extraction only) and the right side (ridge preservation). Ridge preservation seems to be a suitable technique to enhance the hard-tissue situation.

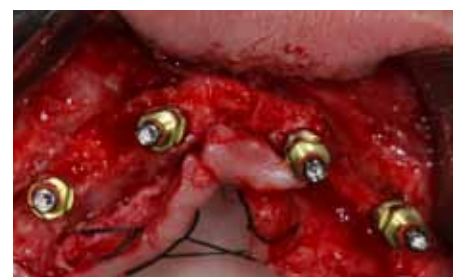
Fig. 9: Insertion of four implants (3.8mm x 13mm).

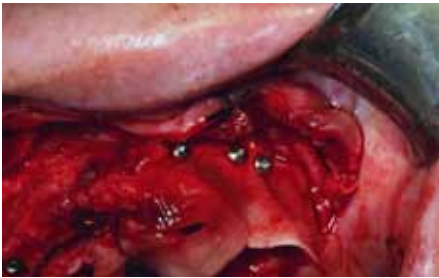
Fig. 10: Bone augmentation with Bio-Oss® and Bio-Gide® to increase the bone volume. The membranes were fixed with ALTApins.

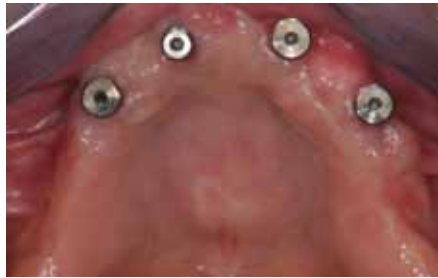
Fig. 11: Clinical situation prior to the third surgical intervention after 12 weeks. The occlusal view showed a healthy soft-tissue situation around the anterior implants.

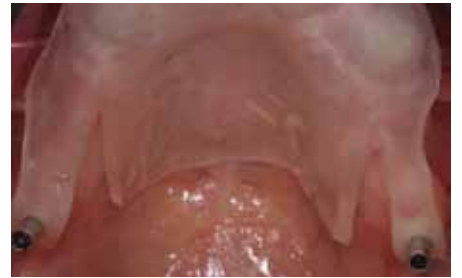
Fig. 12: Insertion of implants in the tuber maxillae. The surgical stent supported by the four anterior implants was used to place the implants in an optimal position.

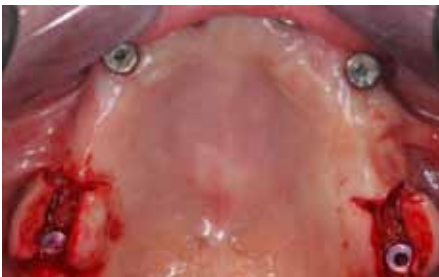
Fig. 13: The implants placed in the maxillary tuberosity. The precise surgical guide system using the precise CT data is necessary for the exact placement of the implants in the correct positions.

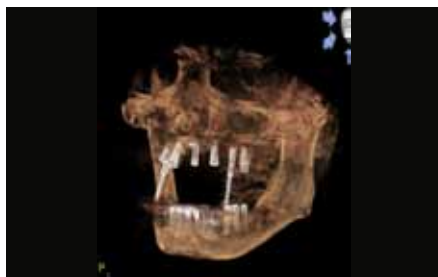
Fig. 17: In order to verify the exact positions and the depths, CT(3D) data were taken with the depth gauges during the surgery.

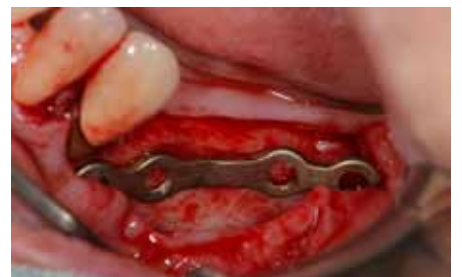
Fig. 18: Removal of the mandibular titanium plates.

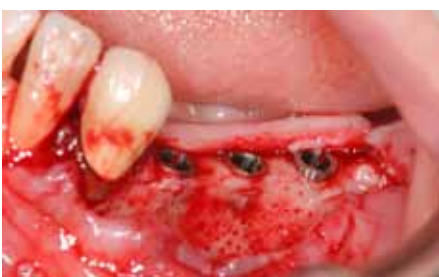
Fig. 19: Insertion of five implants (3.8mmx13mm): three implants on the left side and two implants in the right mandible.

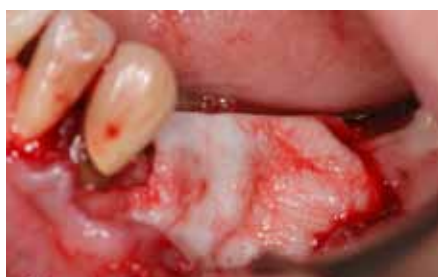
Fig. 20: For obtaining the necessary bone volume in the buccal side, bone substance was used and covered with the resorbable membrane.

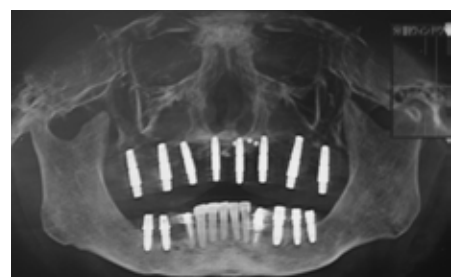
Fig. 21: Postoperative situation.

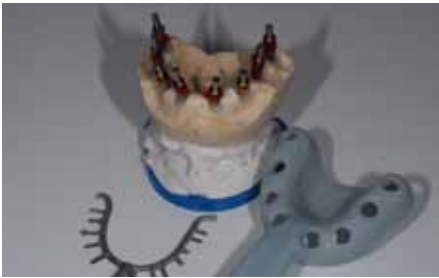
Fig. 22: A custom-made tray for open impression technique was prefabricated on a first master cast. At the same time, a cast metal index frame was made in advance.

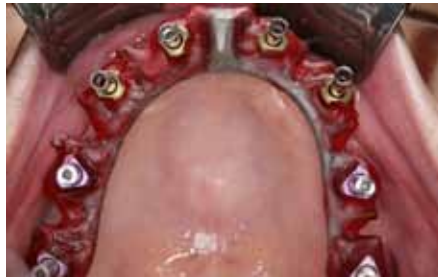
Fig. 23: The occlusal view demonstrated a passive and rigid connection of the impression posts to the metal framework. This prevented any technique-related distortion during impression-taking and later model processing.

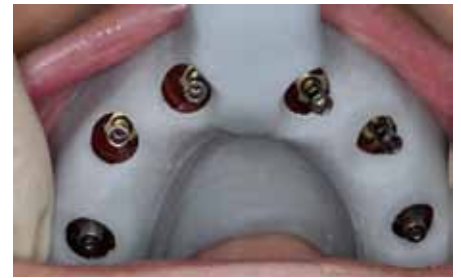
Fig. 24: The impression was taken with a custom tray. The impression posts must not have any contact with the open tray. Using this method, distortion or discrepancies in accuracy can be avoided. This was the basis for a highly accurate master cast to fabricate a very precise framework.

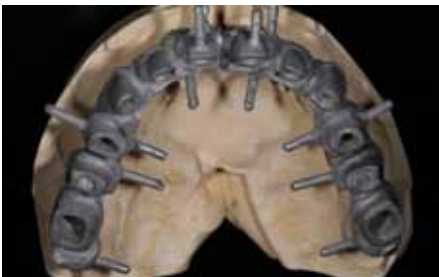
Fig. 25: The framework was designed as a one-piece cross-arch structure based on eight implants. The restoration was finally cemented on individualized universal titanium alloy abutments.

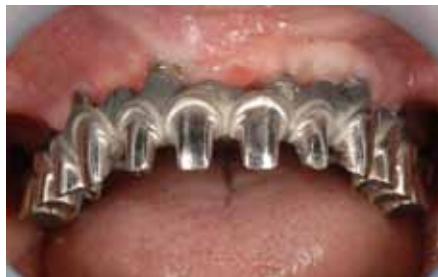
Fig. 26: Framework try-in on the individually prepared abutments, checking for passive fit of the structure. The restoration was designed for a pink base and single crowns bonded to the metal frame.

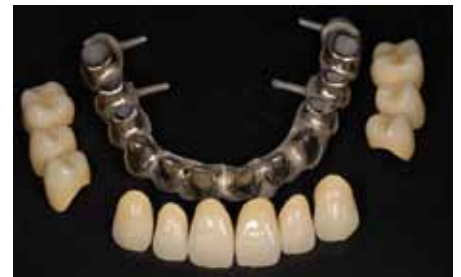
Fig. 27: The individual crowns were cemented to the metal frame utilizing acrylic bonding resin.

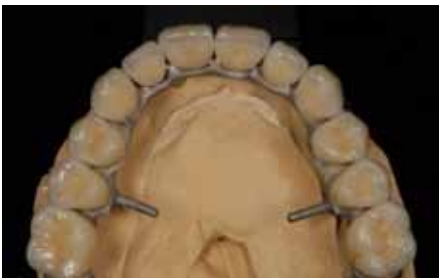
Fig. 28: After cementing the crowns, the gingival part of the restoration was added to the framework.

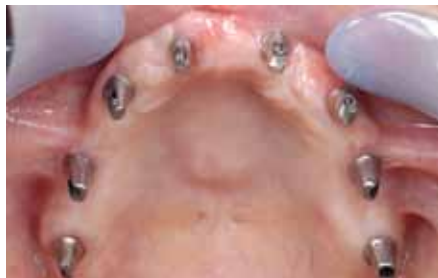
Fig. 29: Healthy soft-tissue situation prior to the installation of the primary provisional restoration.

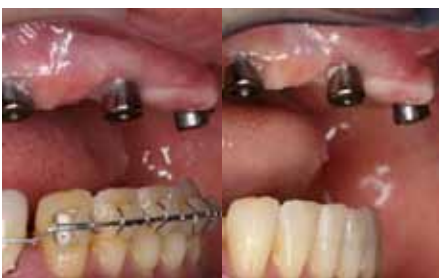
Fig. 31: Orthodontic treatment. The implants were used as anchors in order to shift the teeth labially.

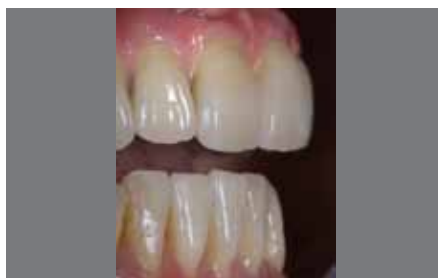
Fig. 32: Final prosthesis in place. In order to achieve a stable occlusion, a vertical stop was created by raising the occlusal height on the molar area.

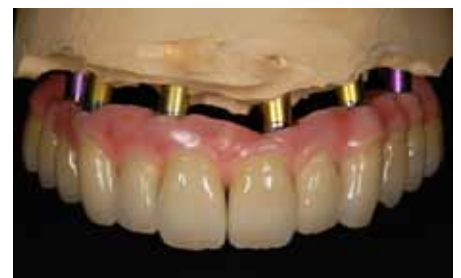
Fig. 33: Hybrid resin was selected for modifications of the substructure.

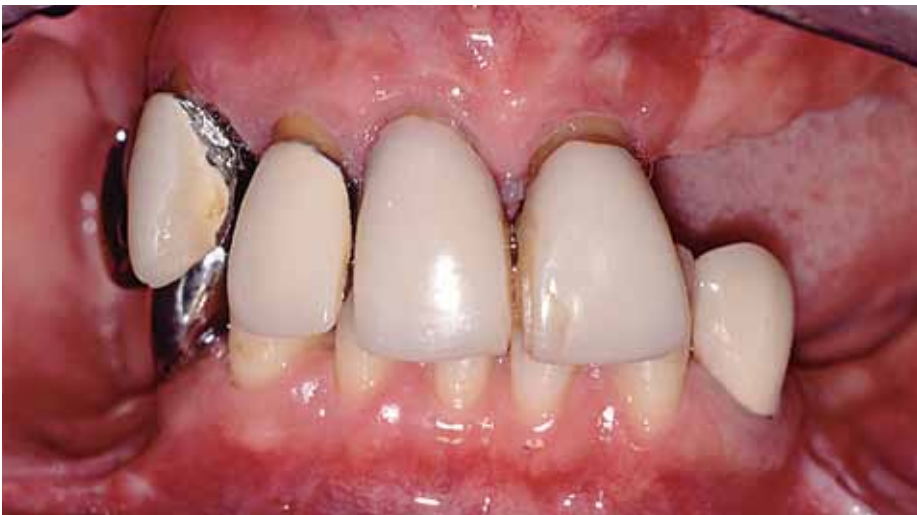
Fig. 34: Initial situation before the start of treatment.

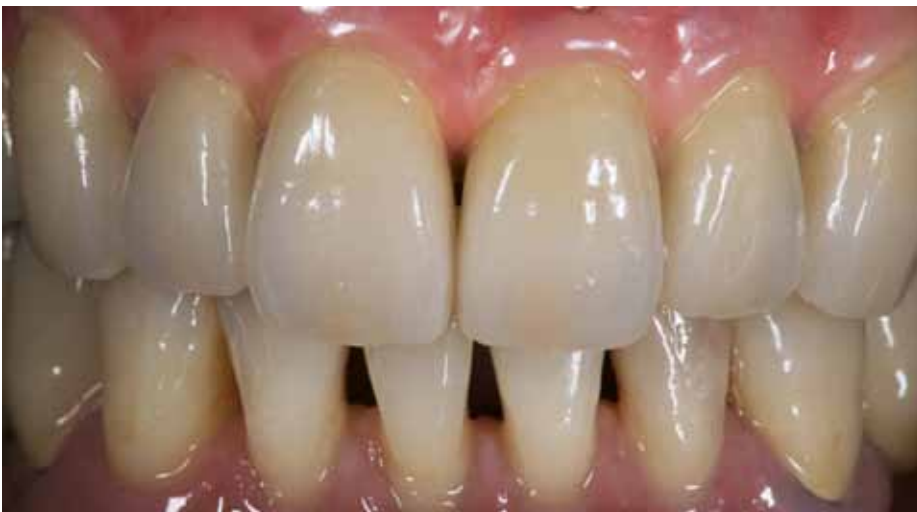
Fig. 35: Clinical situation six years after placing the final prosthesis. Note the clean and stable periimplant soft tissues and well-maintained fixed implant-borne full-arch restoration in the maxilla.
